Rev	Date	Description	By
<p>85a Whiting Street, Bury St. Edmunds, Suffolk, IP33 1NX Tel: (01284) 761444 Fax: (01284) 750337 e-mail: eng@morrish.co.uk www.morrish.co.uk</p>			
Project 11 HIGH BAXTER STREET, BURY ST EDMUNDS			
Title STRUCTURAL CONDITION SURVEY SHEET 1 OF 2			
Drawn	JMR	Checked	JP
Scale	1:50 @ A1	Date	JULY 2019
Drawing No	E272-S-01		Rev

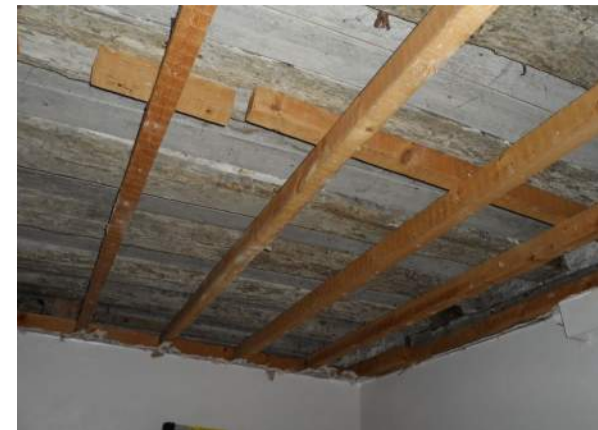
Span A:
Span A consists of 120dp x 150 timber Joists at varying (410 - 450) centres. Joists are in a generally good condition.

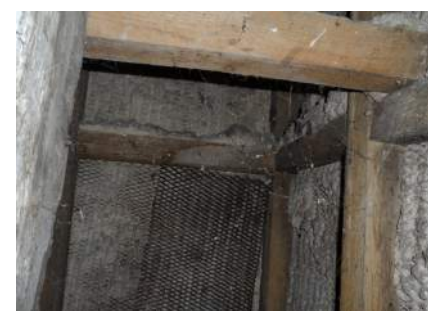
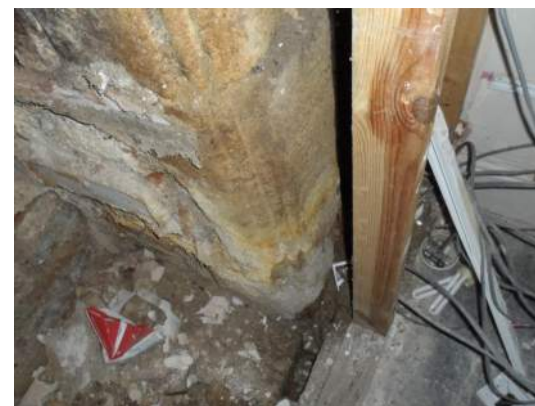
Original wall found to have severe rot to soleplate and base of studs, condition to be inspected by timber specialist. The original studwork is leaning outward at the top. (see images above and to the right)

ALL EXISTING TIMBER IS TO BE INSPECTED BY A TIMBER PRESERVATION SPECIALIST, WHO WILL ADVISE ON THE CONDITION & REQUIRED REMEDIAL TREATMENT.

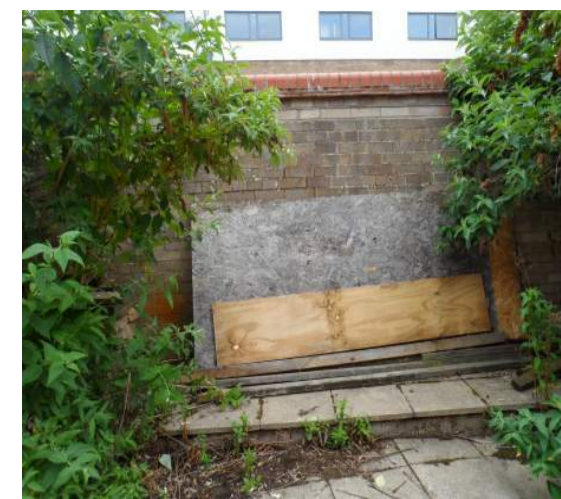
Stepped concrete slab assumed to form the top of mass concrete retaining wall (see image above). Refer to the section detail below for further info.

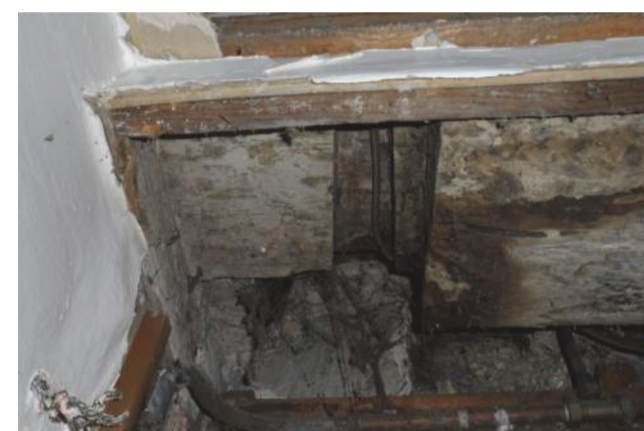
Beam 1:
Beam 1 is a 250x300 timber beam, it is in good condition, there is a large notch at its bearing (highlighted blue), the dimensions of this notch can be seen below on the "Notch detail" (see image above).

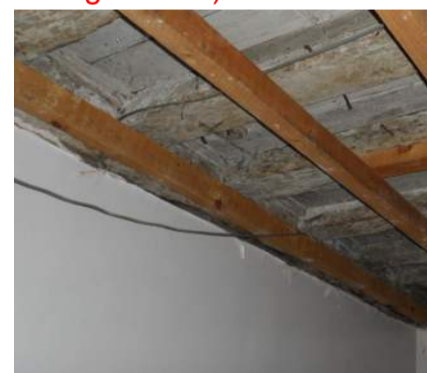
New wall built beneath beam, wall is non load bearing (see image below).

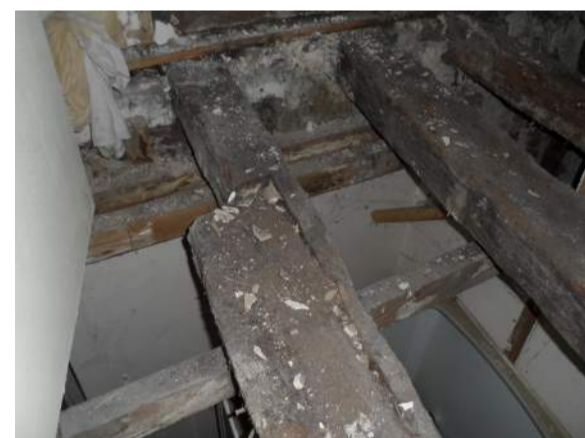
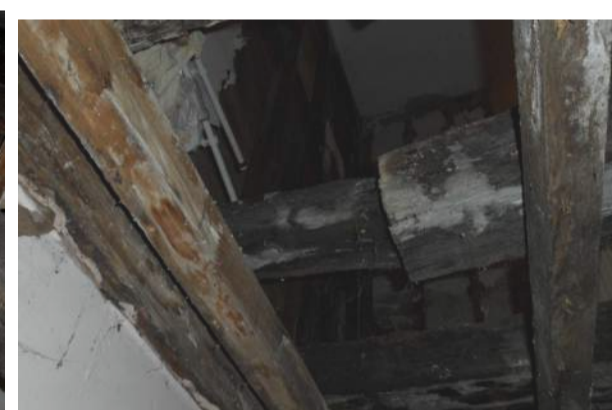
Floor joists in this area, whilst generally solid are suffering from surface rot & 1 No Joist has been badly spliced and has failed (see images to the right).

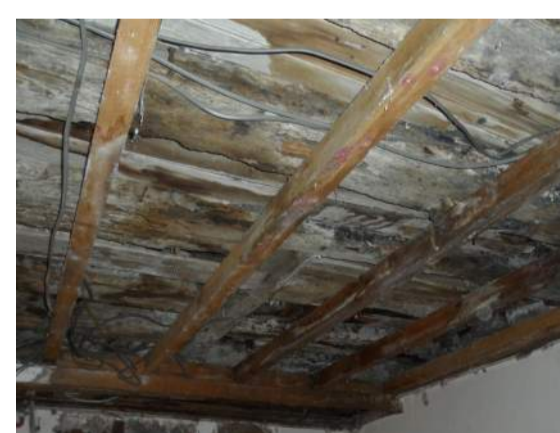
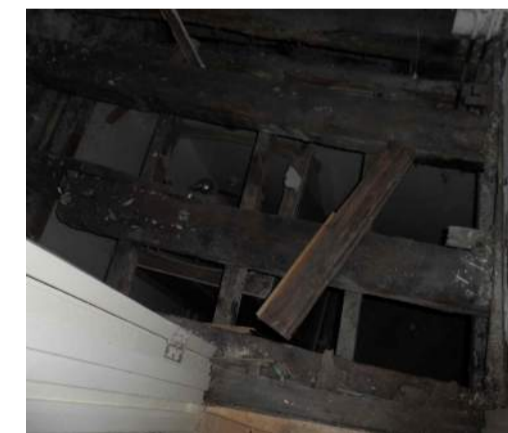
Span B:
Span B consists of 140dp x varies (140 - 190) timber Joists at 450 centres. Joists are suffering from surface rot, but are generally solid. see local notes for more info (see images below).

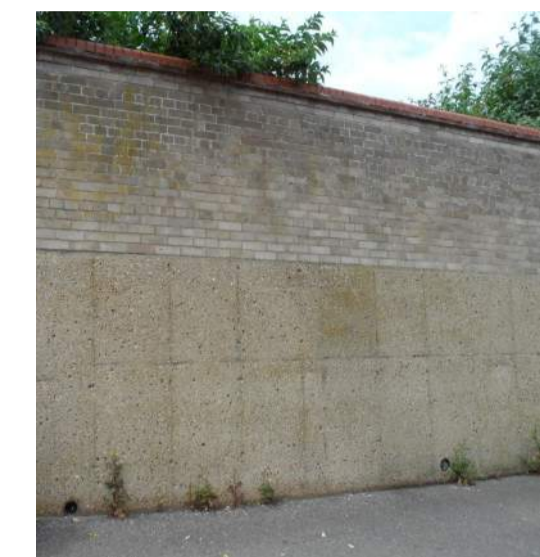
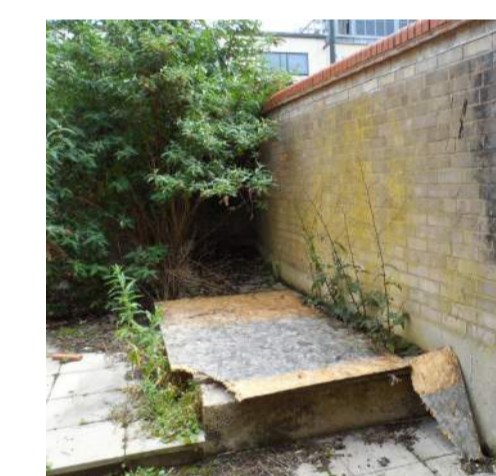
SECTION THROUGH RETAINING WALL
(Scale 1:20)

The exterior of the retaining wall can be observed from the lower car park and from the patio on the property. It is heavily assumed that the concrete slab below the patio makes up the top of the mass concrete retaining wall and extends in to the ground as shown (depth unknown, see images below & above for context).
