<p>85a Whiting Street, Bury St. Edmunds, Suffolk, IP33 1NX Tel: (01284) 761444 Fax: (01284) 750337 e-mail: eng@morrish.co.uk www.morrish.co.uk</p>			
Project			
11 HIGH BAXTER STREET, BURY ST EDMUNDS			
Title			
STRUCTURAL CONDITION SURVEY SHEET 2 OF 2			
Drawn		Checked	
JMR		JP	
Scale		Date	
1:50 @ A1		JULY 2019	
Drawing No			Rev
E272-S-02

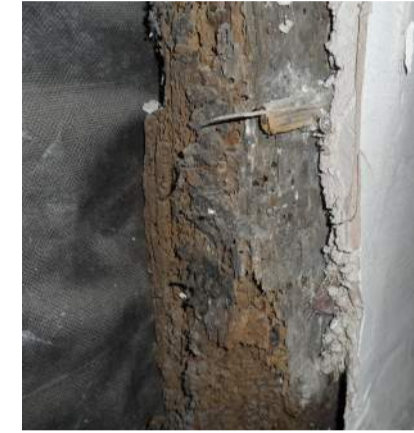
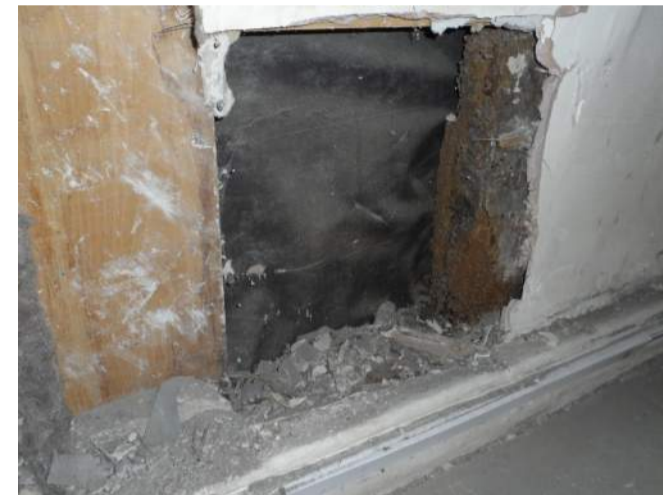
Rot is extending the under window frame, extent of rot unknown, but it is assumed that all timber in this area is affected (see images above for context).

ALL EXISTING TIMBER IS TO BE INSPECTED BY A TIMBER PRESERVATION SPECIALIST, WHO WILL ADVISE ON THE CONDITION & REQUIRED REMEDIAL TREATMENT.

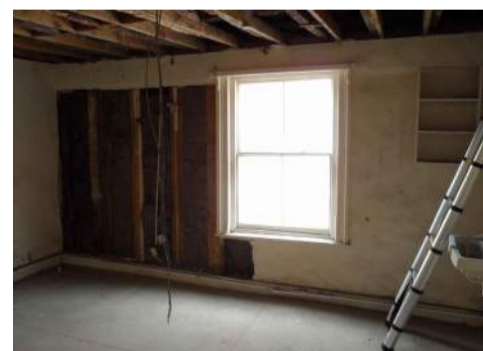
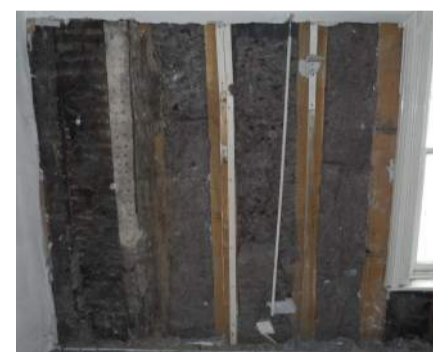
There is evidence of existing repair works, as old studs have been removed and replaced with newer, sturdier timbers (see images below).

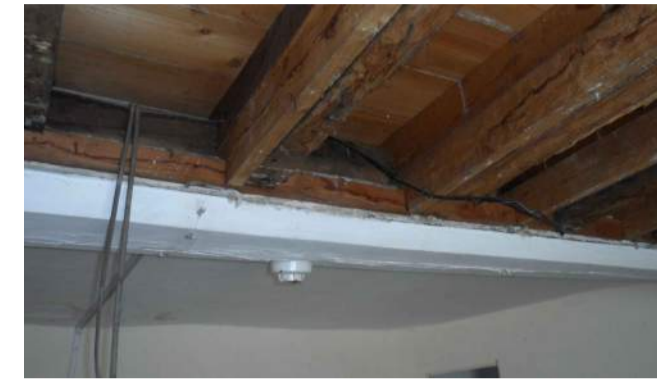
Beam 4:
Beam 4 is a 130x250 timber beam, it also has a 110mm timber over it, this is all in a suitable condition (see the image above for context).

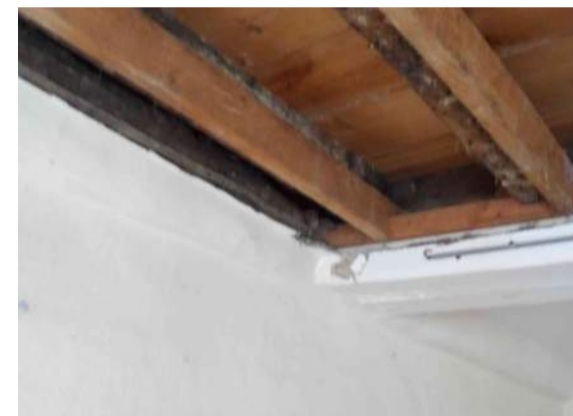
Beam 5:
Beam 5 is a 220x190 timber beam, it is in a suitable condition (see the above image, you can see beam 4 connecting to beam 5).

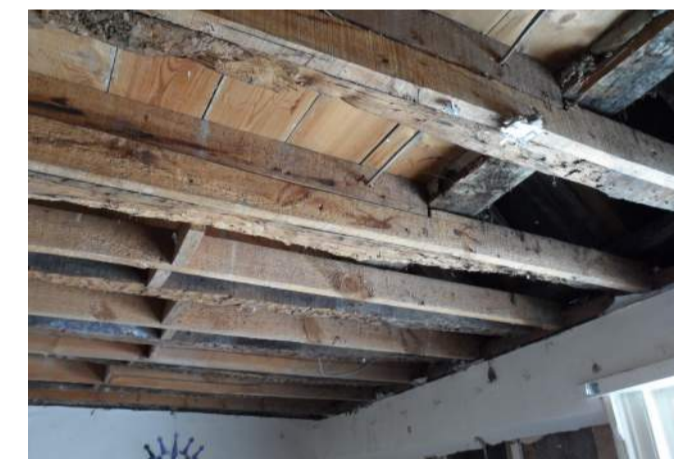
Floor joists over this area have been chopped so that a higher ceiling height could be achieved, they have then been poorly strengthened (see image to the right).

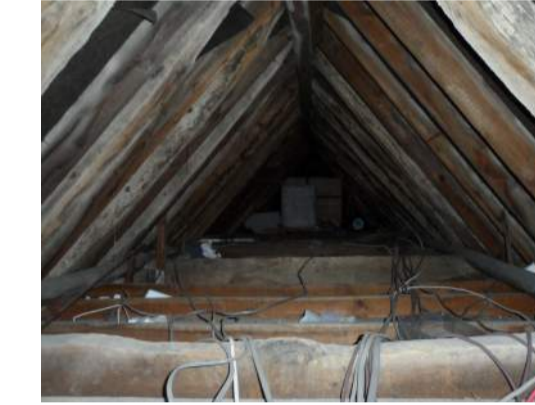
New overlay rafters side lapped at ridge (no ridge board, see above images for context).

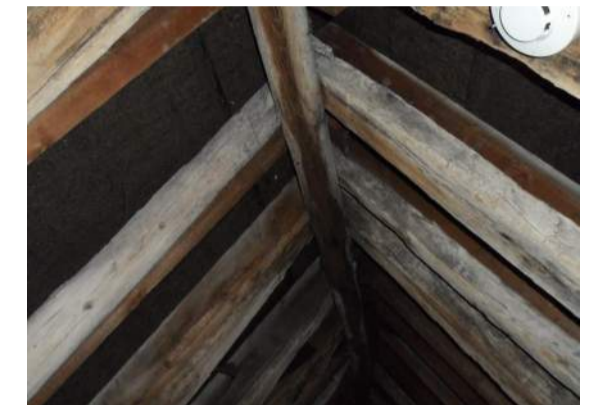
Roof structure formed with shoulder purlins (see above images for context).

The roof itself is generally ok, and it doesn't seem to rely on internal cross walls for vertical support, although they probably provide an undefinable stiffness to the structure.

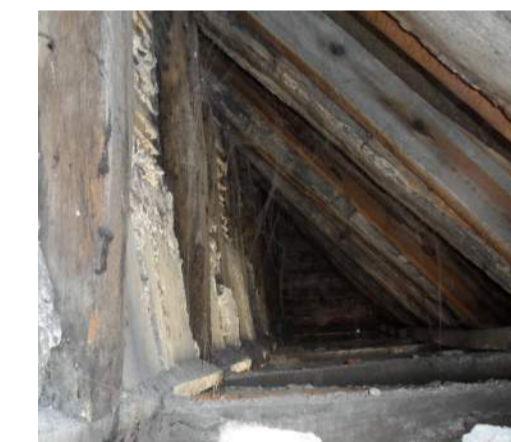
The roof has ashlar walls in its lower construction, these are generally ok (see below image)
