Looms Lane

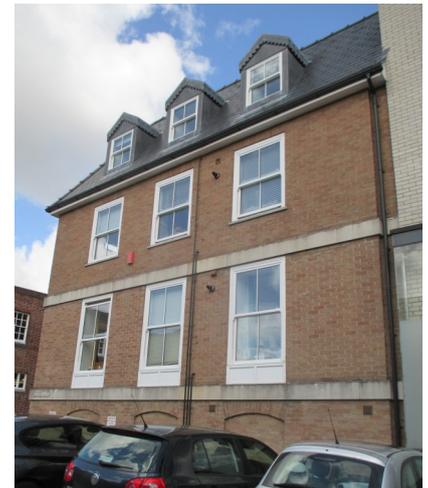
2 Looms Lane - 'Garland House'

With its entrance in Garland Street perhaps it is curious this building's postal address is Looms Lane. It is a 1970s office building mainly in two storeys with a dormered attic. It is in pale buff bricks with a slated roof with artificial stone plat bands at ground and first floor levels. There are three bays of fenestration to Looms Lane and five to the corner block when it returns into Garland Street. To the north of the corner block are two others, the southern most having five bays and repeating some of the detail of the corner, but without plat bands, and then a simpler three bay and three storey element adjacent to the building to the north.

This building has had a recent conversion to residential uses and part of this has seen all the original fenestration and door 'joinery' replaced with plastic. This building was well thought out and not unsympathetic to its location when built but these recent changes have compromised any contribution that it may have made to the conservation area.

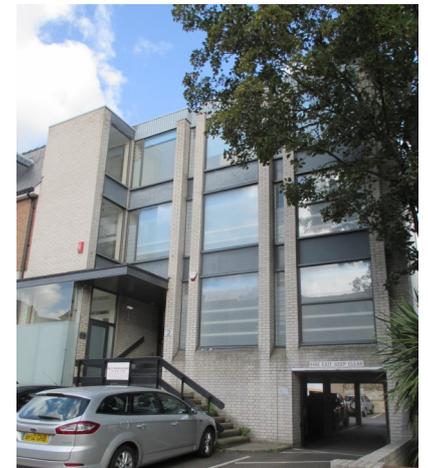
2 Looms Lane Extension

This is an office building in three storeys with a flat roof from the late 1960s/early 1970s and of a type and form that was fashionable during a relatively short period of time. It is built in white calcium silicate bricks and has four bays; that to the west is blind brickwork while the others have full width fenestration with panelled aprons between double shafted columns. The ground floor entrance is above ground level accessed via concrete steps with box steel handrails. This has a canopy and a later added rainscreen in glass. Below the ground floor at the east side is a passage leading to the rear of the building where there is car parking. The building is set back from the street edge and has a small, asphalted area to the front that is used for car parking and which rather spoils the setting of the building. Imagined with a boundary wall with some landscaping, the building would be a small office building of some quality, not innovative or exceptional, but a well-designed building which speaks of its period.

While there are those who will disagree this small office building has some quality and speaks of its period and reflects the architectural fashion of that time. For this reason it makes some modest contribution to the conservation area but this would be improved if, the front area was landscaped and the street had some enclosure.

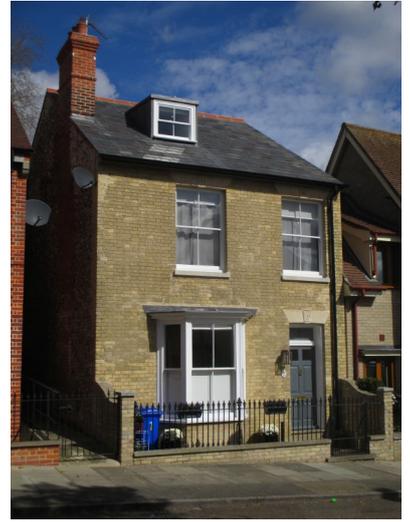
7 Looms Lane

This is a late 19th C house, presumably always detached but the flank walls in flint and red brick suggest this may have been part of a terrace or includes elements of an earlier building - this might be worth further research. The street elevation is two storeys of white brick with a slate finished roof with a small dormer window and a brick stack.

There are two, two over two, sash windows at first floor and a canted hexagonal bay to the ground floor together with the entrance door. All window joinery appears original, but the door is modern. The openings have stone lintols with carved keystones. Plastic rainwater goods.

This house has had a major refurbishment in recent years and part of this refurbishment included the cleaning of the brick and stonework and rebuilding a dwarf brick wall with steel railings to the front boundary. This does rather make the house appear modern like its pastiche styled neighbours which adjoin to the east and west. Notwithstanding that, it is a good historic house in the conservation area to which it makes a positive contribution although the satellite TV dish rather detracts.
