## St Andrew's Street North

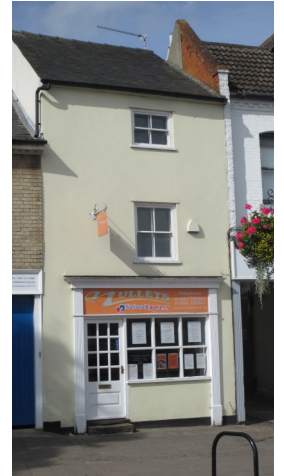
## 6 St Andrew's Street North

This is a stucco rendered building in three storeys and may be 18<sup>th</sup> C but certainly has some age, and is likely to be at least early 19<sup>th</sup> C. It has a slated roof and a single window at the first and second floors, both with 19<sup>th</sup> C two over two sashes. The ground floor has what appears to be a modern shop front in early 19<sup>th</sup> C style, with a six-pane shop window and a multipane glazed door. Plastic rainwater goods.

This is an historic building which may benefit from further research. It is of interest in the conservation area and makes a positive contribution to it.

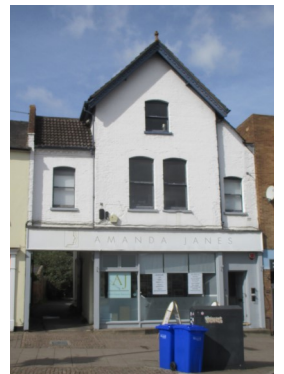
## 7 St Andrew's Street North

This is a mid-late 19<sup>th</sup> C commercial building with residential accommodation above. In three storeys of stucco render and with three elements comprising a central gabled part in three storeys with flanking two storey elements. The south element has a separate double pitched roof and an opening for access to the rear at ground floor and a single window at first floor level. The north element has a cat slide roof contiguous with the roof on the central element, an entrance door at ground floor and a single window at first floor. The central section has a dentiled barge board, single window at second floor and a pair at first floor, while the ground floor has a modern shop front. The roof finishes are modern concrete interlocking tiles. The windows are all one over one sashes, with arched heads. The ground floor joinery is all modern.

Whilst an historic building, the modern changes to this building have rather undermined the interest that the building has. Notwithstanding that, it does make a very modest contribution to the conservation area which would be enhanced with restoration.
