Rev	Date	Description	By
<p>85a Whiting Street, Bury St. Edmunds, Suffolk, IP33 1NX Tel: (01284) 761444 Fax: (01284) 750337 e-mail: eng@morrish.co.uk www.morrish.co.uk</p>			
Project 11 HIGH BAXTER STREET, BURY ST EDMUNDS			
Title STRUCTURAL CONDITION SURVEY SHEET 1 OF 2			
Drawn	JMR	Checked	JP
Scale	1:50 @ A1	Date	JULY 2019
Drawing No	E272-S-01		Rev

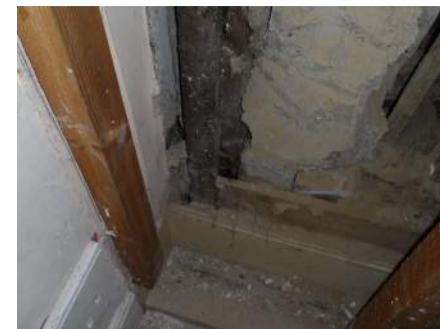
Stepped concrete slab assumed to form the top of mass concrete retaining wall (see image above). Refer to the section detail below for further info.

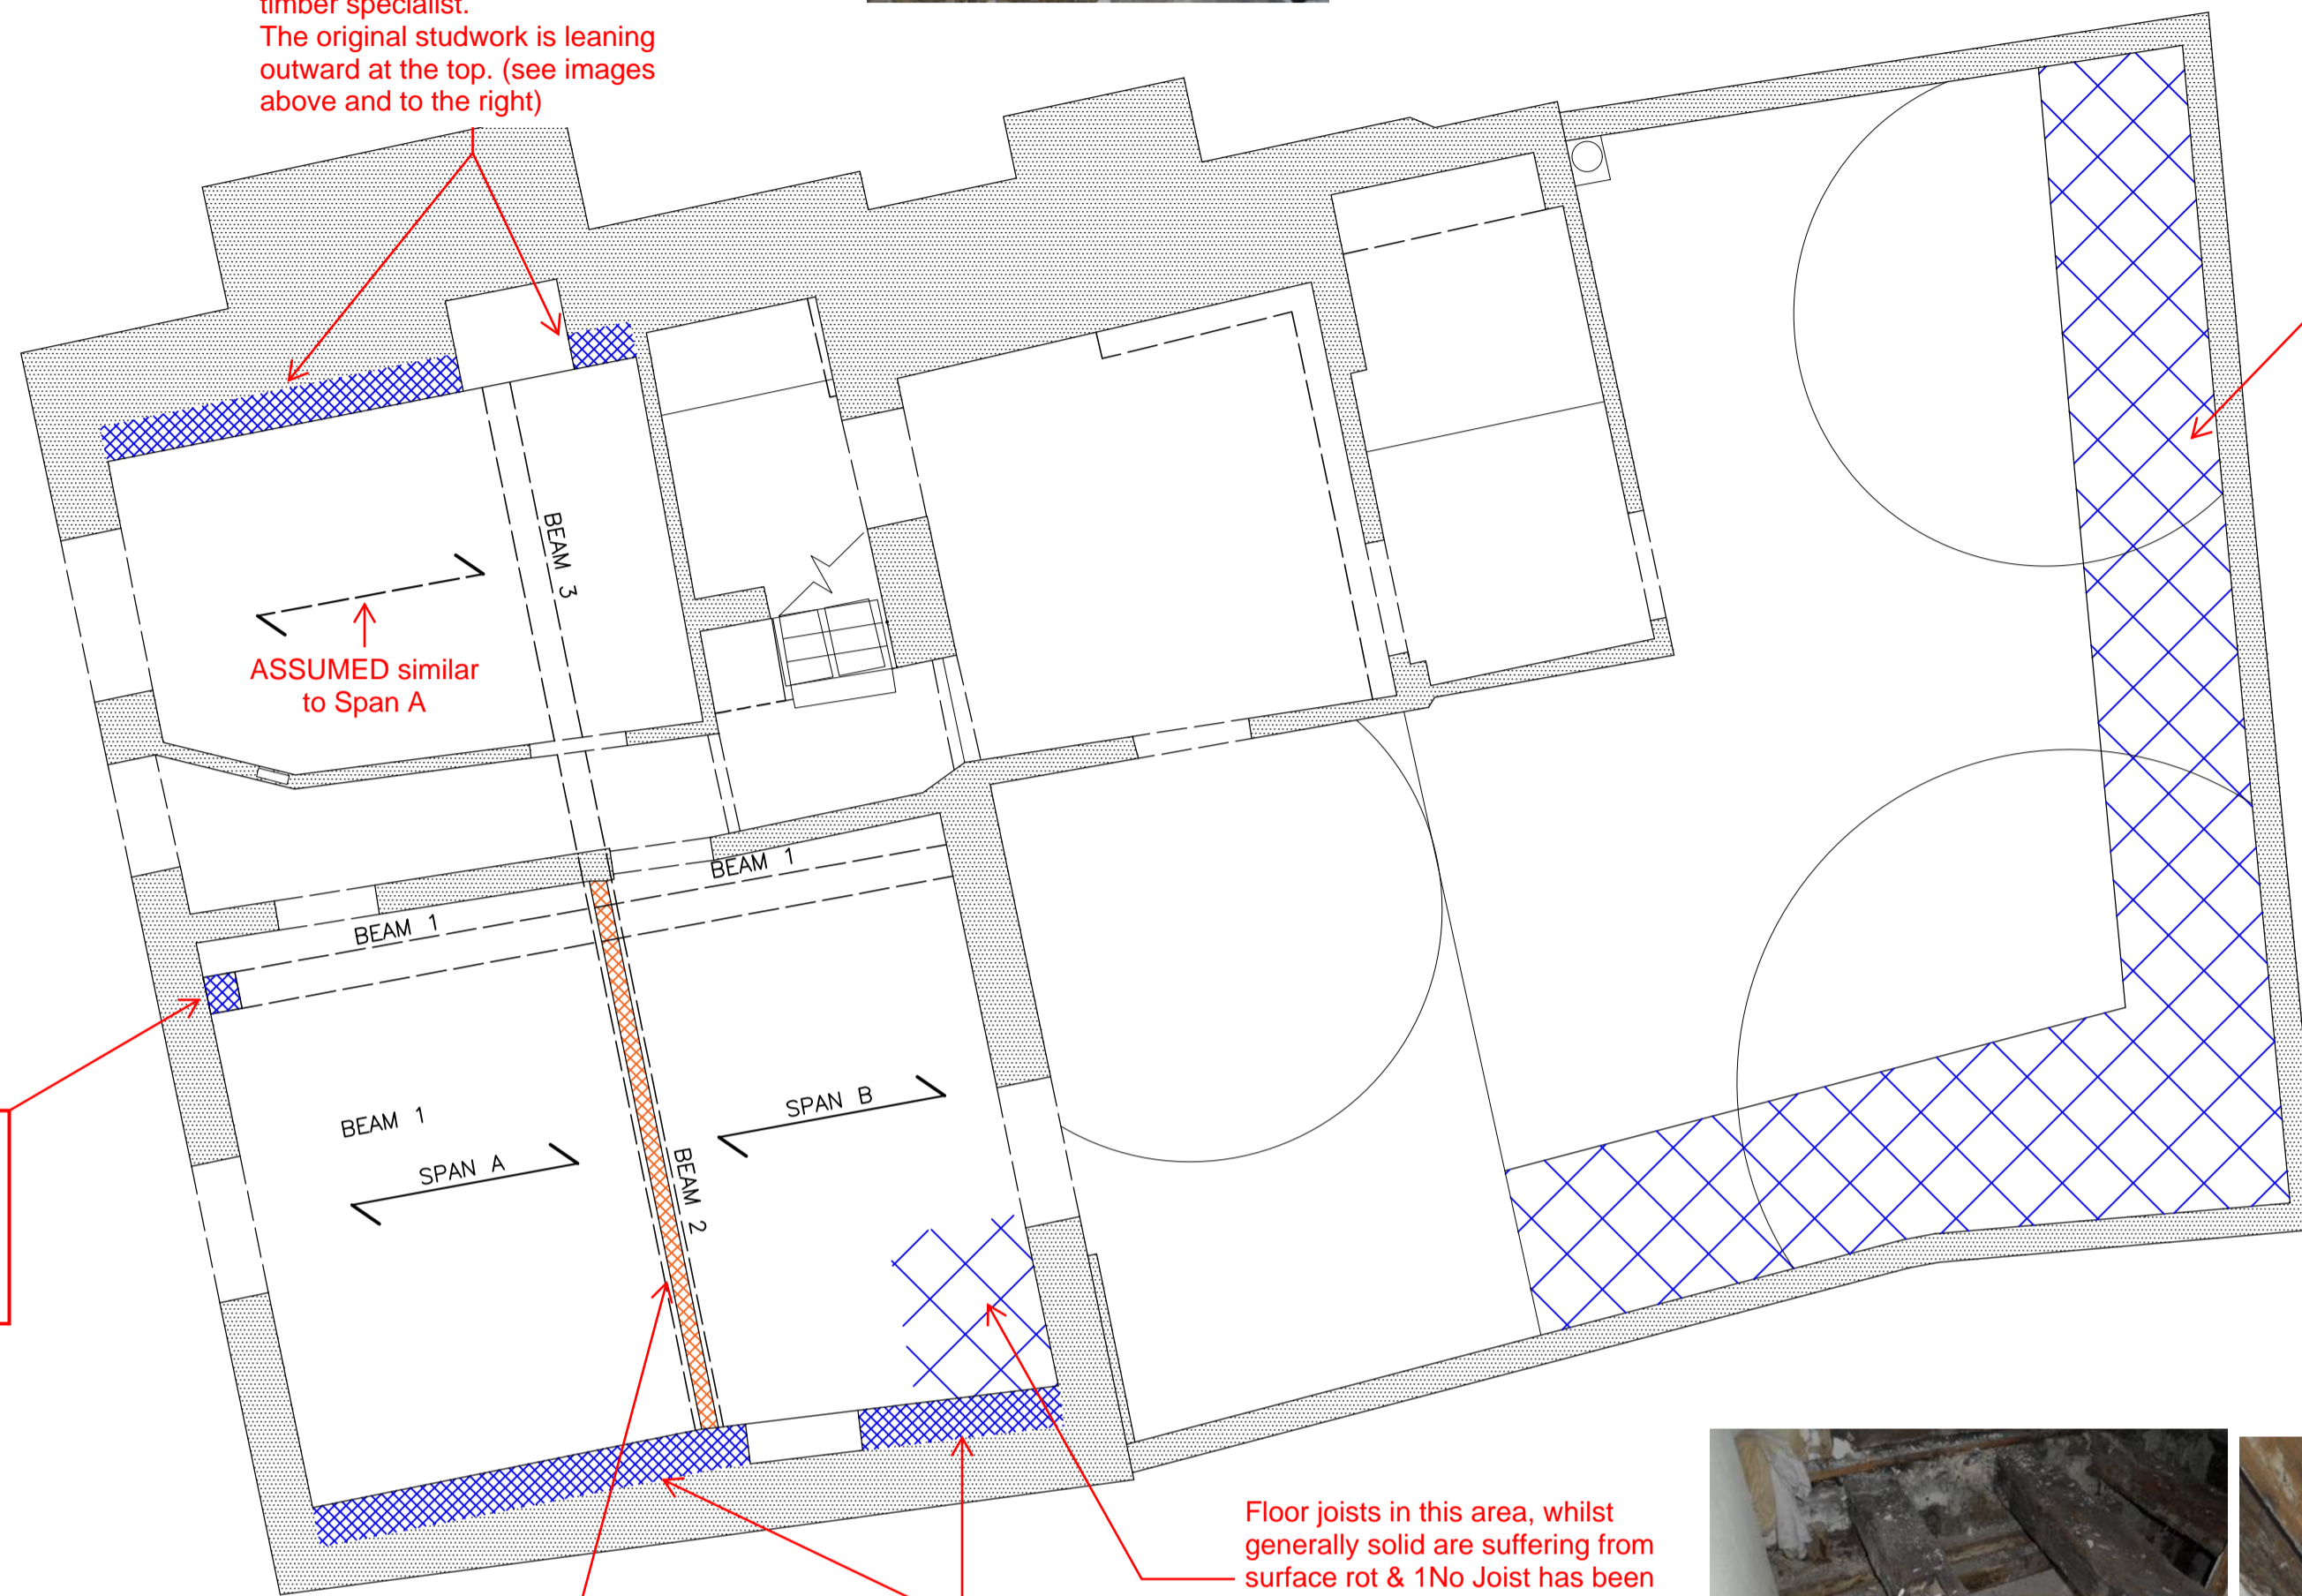
NOTCH DETAIL
(Scale 1:10)

Beam 1:
Beam 1 is a 250x300 timber beam, it is in good condition, there is a large notch at its bearing (highlighted blue), the dimensions of this notch can be seen below on the "Notch detail" (see image above).
