<p>85a Whiting Street, Bury St. Edmunds, Suffolk, IP33 1NX Tel: (01284) 761444 Fax: (01284) 750337 e-mail: eng@morrish.co.uk www.morrish.co.uk</p>			
Project			
11 HIGH BAXTER STREET, BURY ST EDMUNDS			
Title			
STRUCTURAL CONDITION SURVEY SHEET 2 OF 2			
Drawn		Checked	
JMR		JP	
Scale		Date	
1:50 @ A1		JULY 2019	
Drawing No			Rev
E272-S-02

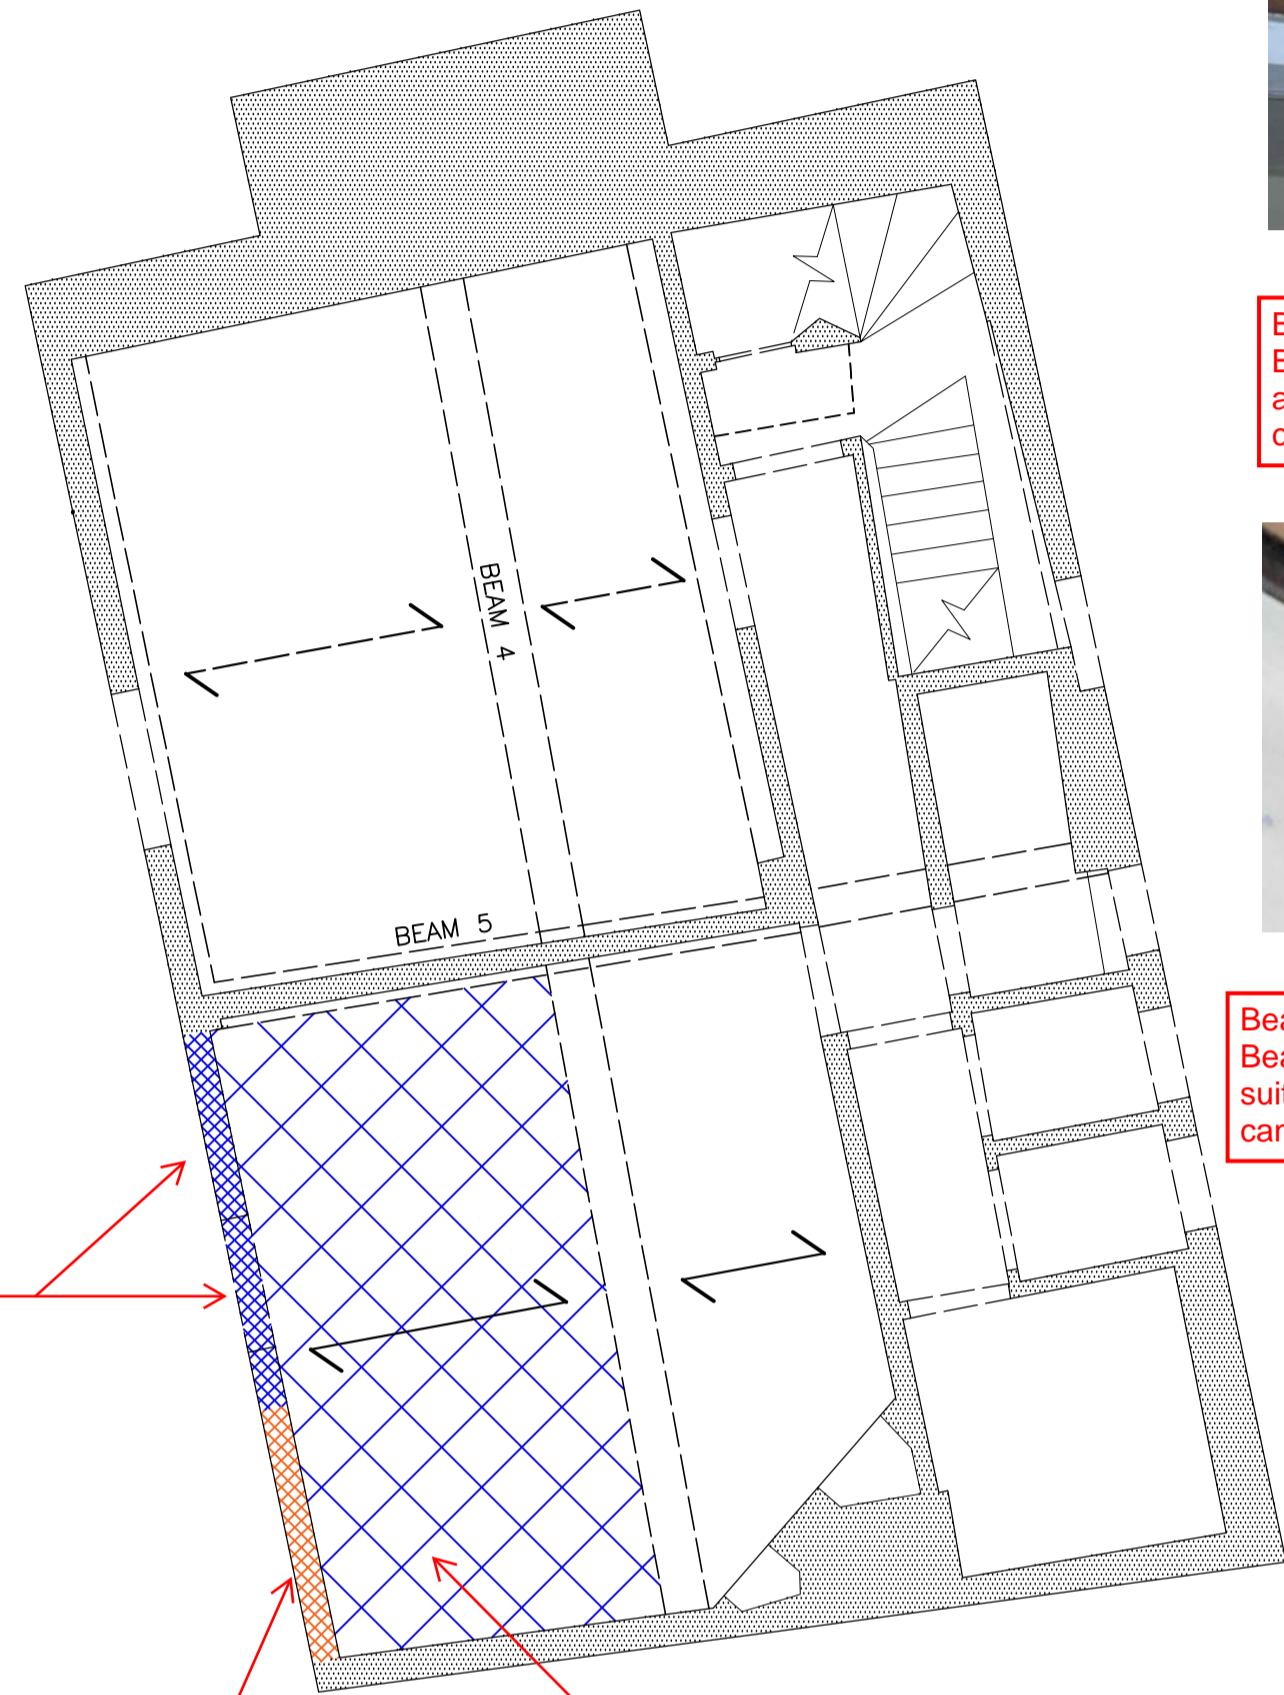
PLAN AT FIRST FLOOR LEVEL
SHOWING EXISTING STRUCTURE OVER

Beam 4:
Beam 4 is a 130x250 timber beam, it also has a 110mm timber over it, this is all in a suitable condition (see the image above for context).

Beam 5:
Beam 5 is a 220x190 timber beam, it is in a suitable condition (see the above image, you can see beam 4 connecting to beam 5).

Floor joists over this area have been chopped so that a higher ceiling height could be achieved, they have then been poorly strengthened (see image to the right).

ALL EXISTING TIMBER IS TO BE INSPECTED BY A TIMBER PRESERVATION SPECIALIST, WHO WILL ADVISE ON THE CONDITION & REQUIRED REMEDIAL TREATMENT.

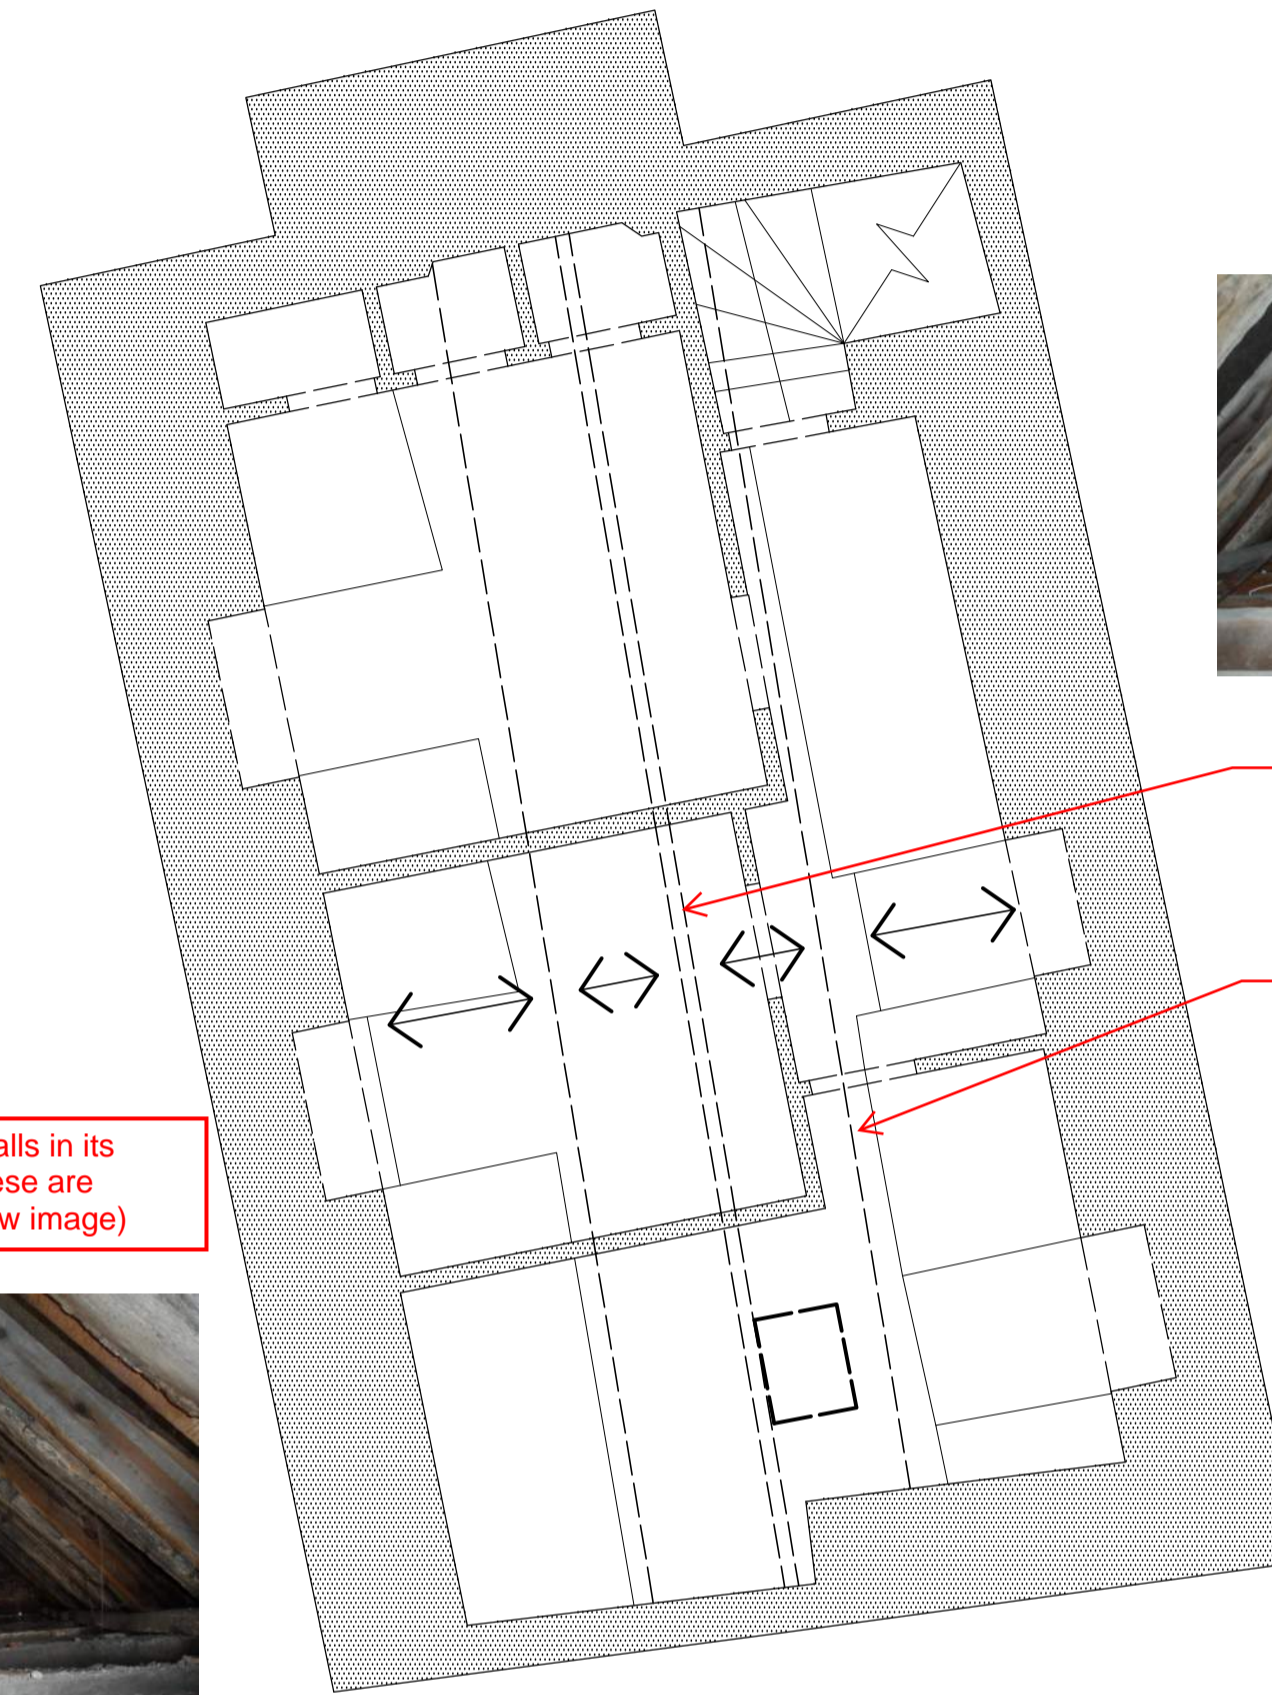
PLAN AT SECOND FLOOR LEVEL
SHOWING EXISTING STRUCTURE OVER

New overlay rafters side lapped at ridge (no ridge board, see above images for context).

Roof structure formed with shoulder purlins (see above images for context).

The roof itself is generally ok, and it doesn't seem to rely on internal cross walls for vertical support, although they probably provide an undefinable stiffness to the structure.

The roof has ashlar walls in its lower construction, these are generally ok (see below image)
