Looms Lane

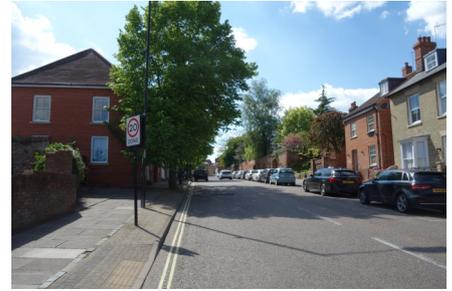
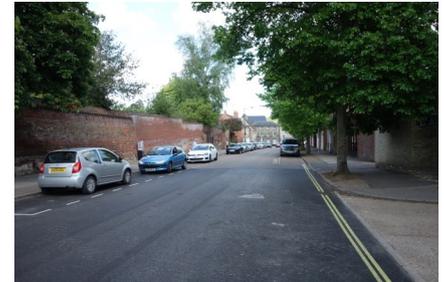
Also on the north side of the street is a large wall to the grounds of Regency House. This is in red brick and is in large part 18th C but has earlier elements too, including pieces of 'Abbey' stone. The wall is a very important feature in the street and conservation area.

Asphalt road with concrete flags and brick pavings. Modern highway lighting on tall standards.
