## St Andrew's Street North

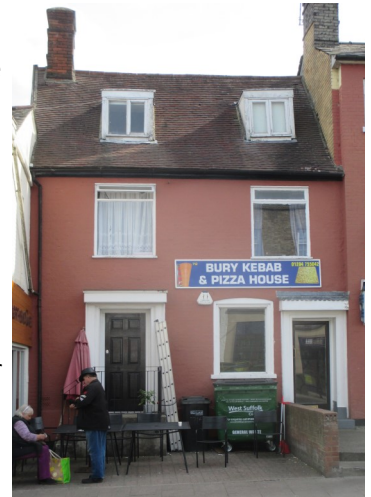
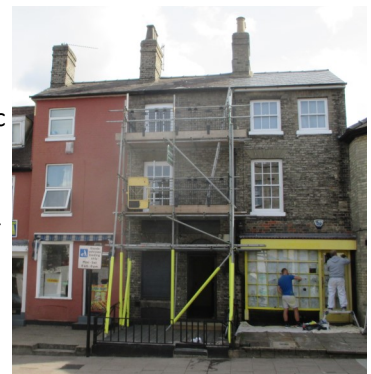
This is a handsome group which make a positive contribution to the conservation area despite of the detracting modern alterations. If No 73 were restored to complete the homogeneity of the terrace, the contribution would be substantially enhanced.
