## Buttermarket

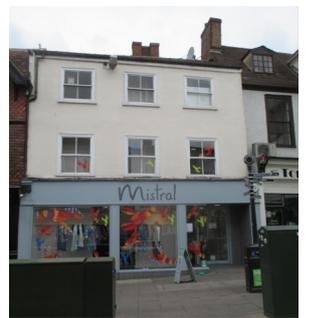
### 2 Buttermarket - Mistral

A building which in appearance could be any age between the early and mid 19<sup>th</sup> C, and in three storeys with stucco rendered walls above a modern almost fully glazed shop front at ground level, with a recessed entrance and two panelled mullions supporting a deep fascia and shallow stall riser. The three bays of fenestration above has quartered sashes in architraved boxes flush with the stucco face. Flush eave with, apparently, a clay tiled roof. Red brick chimney stack, plastic rainwater goods.

A building which would benefit from further research and one that makes a positive contribution to the conservation area.

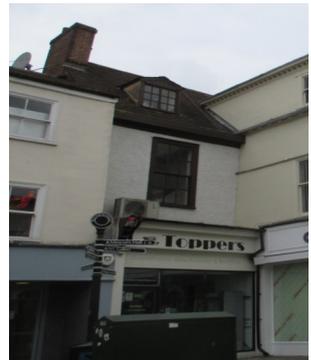
### 3 Buttermarket - Toppers

A very small building in two storeys with a steep tiled roof containing an attic with a wooden framed dormer. The building is, presumably, late 19<sup>th</sup>/early 20<sup>th</sup> C with rough-cast render at first floor level and a modern glass shopfront at ground level with what appears to be a late 19<sup>th</sup>/early 20<sup>th</sup> C surround, with a large wooden corbel bracket, cornice and pilaster.

Fenestration is a single multi-pane sashes at first floor and casements to the attic. Red brick chimney stack, a wooden fascia hides forms a parapet at eave level.

Large and detracting air conditioning plant fixed above fascia.

While the shop front could be better, the building is, overall, positive in the conservation area.

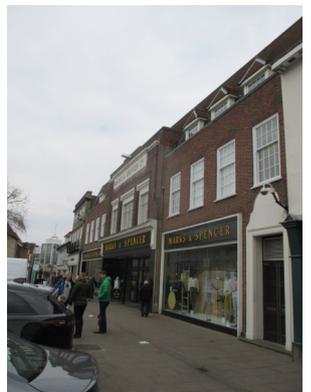
### 23 Buttermarket - Marks and Spencer

An inter-war provincial Marks and Spencer building, designed in the house style of a sort of sub-Lutyens neo-Georgian building with 'art deco' stylistic affectations. The building is in three parapeted bays of a symmetrical composition with the centre bay breaking forward of the two flanking with two tall storeys and an attic with a clay tiled roof with three wooden framed dormers to each of the side bays. The first floor is in brown brick and to the latter has four bays of fenestration while the centre has a trio of feature windows in painted surrounds below a stone cornice and fascia, engraved with the shop's title.

At ground level are three large glass plate shop fronts, each with large fascia with more branding in raised gilt letters, The central bay has modern shop entrance doors. At the south bay is a panelled door with a rather detracting modern grille above, this has a low relief stone architrave, with a pediment in a sort of Dutch style. Fenestration otherwise is multipane sashes to the first floor flanking bays and casements to the dormers. The central windows on the first floor are casements with leaded lights. Attic accommodation is believed to have been added as part of significant store expansion in 1980s which saw major additions to rear including footbridge over High Baxter Street.

This is a rather good building with a distinctive house style of this quintessentially British marque, it makes a positive contribution to the conservation area.

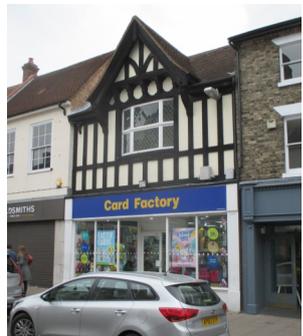
### **33 Buttermarket - Card Factory**

A mock Tudor early 20<sup>th</sup> C small commercial building in two stories, the ground floor having a mid-20<sup>th</sup> C shop front and the first floor being half timbered and gabled with a central shallow bay window with leaded casements. Clay tiled roof, cast iron rainwater goods. Occupies part of a site where four buildings on the eastern side of Buttermarket were damaged by incendiary bombs dropped during a Zeppelin raid in 1915.

A building which adds positively to the richness and diversity of the conservation area.
