Whiting Street

One of the principal north-south streets laid out by Abbot Baldwin in the 12th C and with an extremely rich architectural heritage reflected in high quality building of all ages from the early medieval to the late 20th C, in the form of Langton Place.

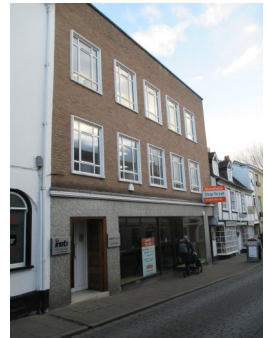
3 Whiting Street

Large, undistinguished, 3-storey commercial building of the 1950s or 60s, with retail on the ground floor and offices above in an 'international style' derived idiom. The rather good bronze shop glazing on the ground floor is surrounded by small-squared mosaic tiling. Above is buff brickwork with five large steel framed windows on each floor, which are set within painted concrete cases. There is a flat roof and concrete coping to the parapet. Only the general size and proportions of the windows is in keeping with the surrounding buildings.

A building which is redolent of a particular age rather than a particular place but of limited quality and neutral in the conservation area

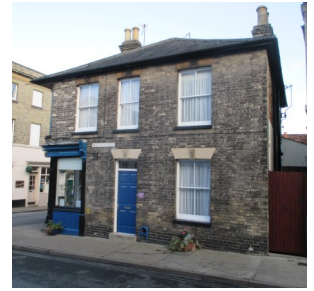
17 Whiting Street

With elevations on both Churchgate Street and Whiting Street this is a large Victorian cottage of white (Woolpit?) brick, the corner of which is attractively curved and occupied on the ground floor by a small shop - in itself attractive. There are wood panelled stall risers, and decorative console brackets above pilasters which frame the windows, doors and signage frieze.

The Whiting Street elevation has one sash window on the ground floor and three above. The Churchgate elevation has one sash below with two above. The windows have shaped stone lintels with central embellished faux keystones. The half glazed panelled front door has a rectangular plain glass fanlight. On the curved corner is a blind window, currently painted up to advertise the shop below. The hipped roof is of slate and there are two corbelled chimney stacks.

Plastic rainwater goods

A remarkably intact mid-late 19th C purpose built shop with residential accommodation over and positive in the conservation area.

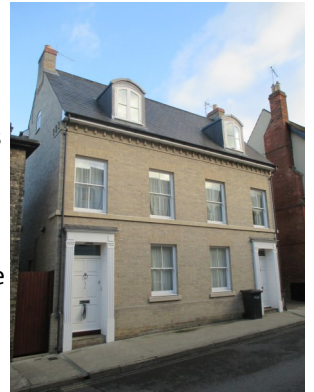
17B and C Whiting Street

A symmetrical pair of modern three-storey townhouses of light brick. The building demonstrates attention to detail and a clear ambition to blend in. A commercial garage/workshop last occupied by 'NW and P Rogers Motor Services' was demolished to accommodate the development which was designed by Milburn Leverington Thurlow and constructed by Mothersole Builders circa 2010-2011.

Each of these well-proportioned houses has a sash window on the ground floor and two above.

Because the houses extend back a long way, there is a large plain side elevation, broken only by two slim sash windows. Each house has a distinctive arched and lead clad dormer window, adding to the period look of the early 19th C. There are gauged brick lintels and stone sills. Of the same stone is a plat band in the brickwork between the ground and first floors. The front doors have six raised and fielded panels and are set in wooden case which are in a sort of Georgian style.

The roofs are of slate and the chimney stacks have red brick topping corbels decoration. Below the overhanging eaves is a dentiled brick decoration.

Metal rainwater goods

Conspicuously conscious of their setting, these are houses designed to fit in to the conservation area and, while history will judge their quality, they are certainly better than neutral in the conservation area.

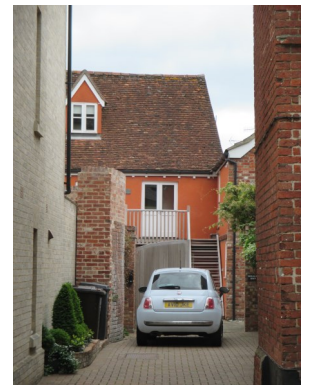
Steggles Barn

Former barn now converted to house. Situated in backland position behind Nos 17B and 17C and in separate ownership to those properties. The front of the property (west elevation) is visible from Whiting Street along an access drive. Converted to residential use circa 2000 to a scheme by Wincer Kievenaar Partnership. Exposed timber framing internal-ly but further would be research required to establish age and history of building.

In 2 parts with principal element of barn located on north-south axis. This part of building is two storey with attic accommodation having been added probably as part of residential conversion scheme. Stucco rendered with plain tile roof and 2 pitched roof, stucco sided dormers. Windows are mix of 2 and 3 light timber casements with french casements forming the ground floor entrance. Further pair of French casements at first floor level giving access to a small timber balcony supported by 2 posts.

The second element appears to be an addition to the south of the main barn. This has a lower roof and consists of a forward projecting gable that is part stucco rendered with the west elevation being constructed of red brick. Fenestration consists again of a mix of casement windows and French casements. The two elements of the building together are 'L' shaped and form the northern and western sides of an enclosed courtyard.

Although views of the building from the public realm are limited, the property makes a positive contribution to the conservation area and, subject to further research, may be of listable quality due to its age and rarity.

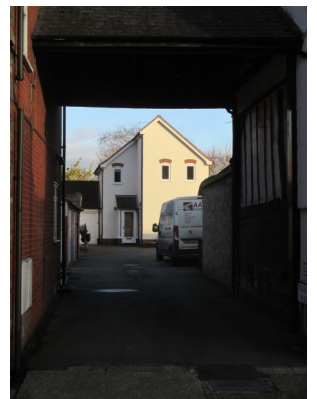
Finsbury Place

To access this residential area from the north it is necessary to pass through an archway covered by a slate roof which seems to have some age.

The area, built by Warren Builders in the 1990s, contains six houses of two storeys in red brick and a variety of designs – some with integrated garages. There are also 15 privately owned garages – some rented - contained within this walled, and concrete block paved area.

As the houses are approached there is an old flint and stone wall, with blocks of old stone at the corners and end. There has been some attempt to reflect the old wall in newer walls in the area but with limited success.

There is another entrance/exit passage to the south.

A discrete backland development not readily visible from Whiting Street and which has limited impact on the more historic parts of the conservation area. At worst neutral in its contribution.

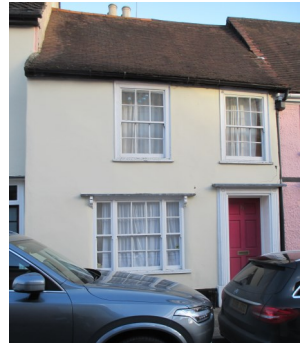
35 Whiting Street

This appears to be a stucco rendered two storey cottage of the early 19th C but is actually a 20th C pastiche.

It has two multi pane sash windows on the first floor and one on the ground floor. These have horns and, therefore, this suggests they are much more recent than the 19th C. The rather obviously modern six panelled front door has Regency-style wooden doorcase but this too seem more likely to be later 20th C. This is need of repair. There are lead clad weatherings over the door and ground floor window. The roof is tiled.

Plastic rainwater goods

Quite a convincing reproduction and at worst neutral in its contribution to the conservation area.

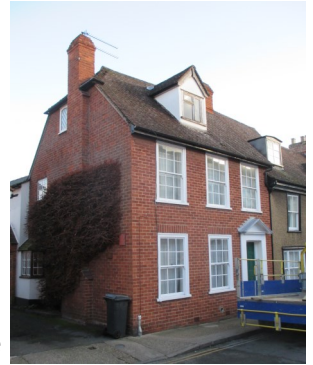
39 Whiting Street

1970s red brick (in stretcher bond) two storey house with Queen Anne affectations.

There is a clay tile roof and two brick chimney stacks and a tiled dormer with a casement window.

On the first floor there are three sash windows and on the ground floor two sash windows all with exposed sash boxes. There is a wooden dummy door in a pedimented case.

To the side is a large two storey extension where the house entrance door is now situated. Here there is a mixture of Crittall type steel and iron framed windows (1860 dated) as well as a bay window and oriel arranged almost as a miscellany of fenestration.

Metal rainwater goods

This is a rather charming cottage and an imaginative reflection of a historical style and positive in the conservation area.

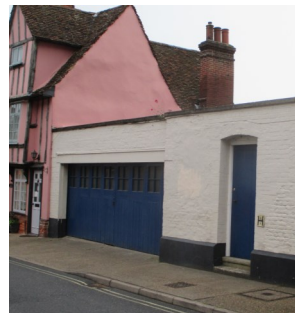
Garage South of 60 Whiting Street

Attached to No 60 is a flat roofed double garage with a sliding wooden door entrance set within a painted brick wall. The doors, which are extremely wide for a residential garage, are half glazed and seem to date to the 1950s/60s, which is presumably when the building was constructed.

There is a large deep beam over the opening which has a wooden fascia.

Although a rather large opening, the traditional doors make this less intrusive in the conservation area than might otherwise be the case and its contribution is neutral.

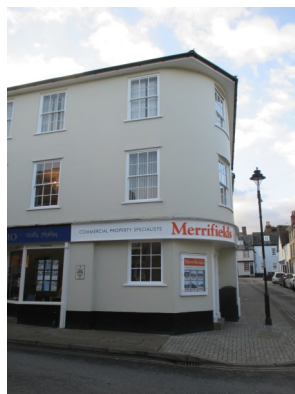
72-73 Whiting Street

This is a three-storey building of four bays on Whiting Street and four on Churchgate Street in a Georgian revival style but, presumably a well done reproduction of the 20th C. It is in commercial use with stucco rendered walls and glass shop fronts at ground level. There is a continuous shop name frieze at first floor level below which are the canted wooden framed shop fronts and, on the corner, the entrance to the offices above, with a six panelled door set within a Georgian style door-case. The corner is turned with a curved wall above the office entrance.

On each of the first and second floors there are four multi-pane sash windows with horns (which rather give away the true age of the building) to each elevation.

There is a clay tile roof and plastic rainwater goods.

A handsome and rather convincing Georgian revival building which makes a positive contribution to the conservation area.

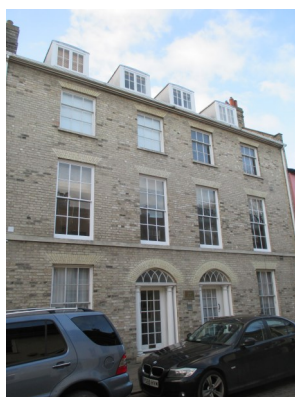
81-82 Whiting Street (Harewood House)

This is a pair of three storeys, plus attics, late Georgian houses built of white bricks in Flemish bond with four bays of fenestration with gauged lintels and stone cills. There is a stone plat band at first floor level. There is a slate roof with lead clad dormers with multipane casement windows.

Otherwise the fenestration is multipane sashes without horns. On the ground floor are paired entrance doors with arched openings with engaged columns flanking multi paned doors which rather give away that the building is not of the period it appears to be. Above the doors are Gothic styled fanlights

There is a stone band between the first and ground floors.

A placard tells that the building received the Bury St Edmunds Society Award for 1987, which helps explain why the building is not listed. This is because it was in such poor condition before restoration in 1986 that its elevation to the street had to be dismantled and rebuilt, with the original bricks reversed.

Plastic rainwater goods.

Early 19th C properties which perhaps should be reconsidered for statutory protection but certainly positive in the conservation area.

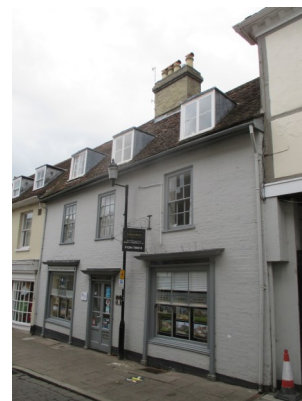
88 Whiting Street (Sheridans)

A commercially used property, but presumably originally a house, nestled amongst a host of listed properties.

It appears to date to the early 19th C in two storeys of painted brickwork in Flemish bond with an attic. There are three bays of fenestration with gauged lintels to the first-floor windows and the attic, set in a tiled roof, has lead clad dormers with casements. The ground floor fenestration consists of two large three over three sash windows in pilastered cases and double half glazed entrance door in a similar case, and the windows otherwise are multi paned sashes without horns.

There are signs of an arched lintel to a cellar opening.

There is a large chimney stack of Woolpit brick.

Metal rainwater goods.

This building is a conundrum: it is a puzzle why it is not statutorily protected being of apparent historic interest from its appearance and having group value in association with adjacent listed buildings. It makes a strong positive contribution to the conservation area.
