High Baxter Street

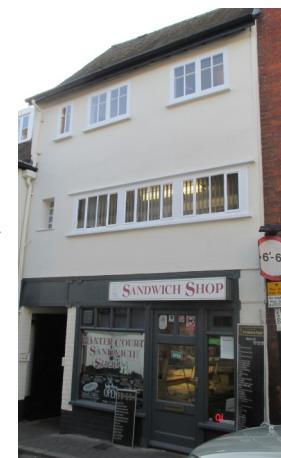
17 High Baxter Street

It is a simple building in three storeys with a ground floor shop unit, with separate access to the upper floors via a recessed entrance, and the two upper floors appear to be in separate commercial use. The upper floors have a stucco finish while the ground floor is largely a modern faux historic shop front with some painted brickwork. The fenestration to the first floor is most unusual for Bury, with continuous tripartite casements divided into four panes each, stretching almost across the full width of the elevation, with a single multi panes casement at the extreme south. This is redolent of weavers windows but seems too small but, presumably was installed for a craft/workshop type use for this level in the building at some time towards the third quarter of the 19th C. The second floor fenestration is rather more conventional with a pair of bipartite casements and another single at the southern extremity.

There is a simple double pitched roof and no obvious chimney stack. Plastic rainwater goods.

This is a building which could date back to the 17th C. The walls are probably wooden framed and the roof steeply sloping too but it is the conundrum of the first floor fenestration which is beguiling. In some ways it is surprising the building is not already statutorily protected, but it certainly makes a strong positive contribution to the conservation area.

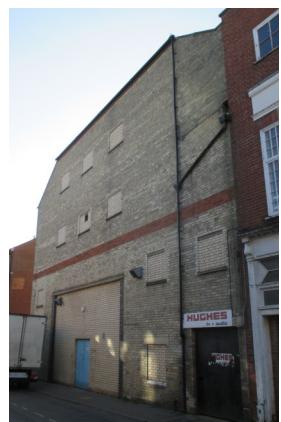
Rear of 29 Buttermarket

This is a large white brick masonry building which was designed for functionality rather than delight. This was clearly the rear parts of a building and there never was any great concern over its appearance. Having said all that the building is in what would approximate to be three tall storeys of white brickwork. The tall ground floor had a service bay which is now infilled, but including flush double doors, with flanking window openings, and another to the north. Above this there is a red brick band and at first and second floors are three window opening to each floor. All the openings in the original masonry have been filled in with bricks in more recent times.

The side elevation clearly had some buildings attached, principally at ground level, until recent times and again is primarily in white bricks and with the red brick band too. There are some steel framed casements somewhat randomly disposed on the elevation and other openings have been infilled in the manner of those on the east elevation. The fly tower seems to survive rising above the general level set back from the street frontage.

While rather sadly compromised this is a building of some limited interest but its contribution to the conservation area is more historic than architectural and modest at best.

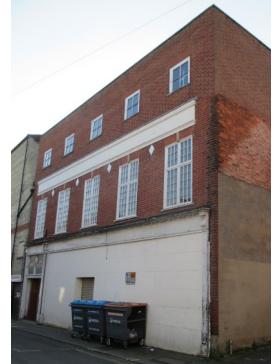
Rear of 27+27a Buttermarket

This is a three (tall) storey building in red brick over a ground floor which was previously a shop front and rear entrance door when occupied by W H Smith. A building from the interwar years, this is of some quality and appears to be largely in its original form with all original fabric. It is in a stripped down neo-classical idiom but very simply detailed.

The ground floor has a modern access to the upper floors at the south end recessed behind an original doorcase which is missing its original doors but does still have its fancy fanlight. The remainder of the ground floor frontage is boarded up with a single roller shuttered opening for access at this level. The frieze does survive with corbel brackets supporting a dentiled cornice. Above this at first and second floors are four bays of windows. Those at first floor have multipane four light casements with gauged flat arch lintols with key stones above which is another frieze with a small cornice to the top and bottom. The second floor windows are simpler two over two casements with flat gauged arches. There is a deep plain parapet hiding the roof. Between the windows on the first floor are small lozenge shaped plates, presumably these are for decoration only.

The alterations at ground level detract from the building but overall, and despite the ubiquitous dumpsters outside, the building makes a positive contribution to the conservation area.

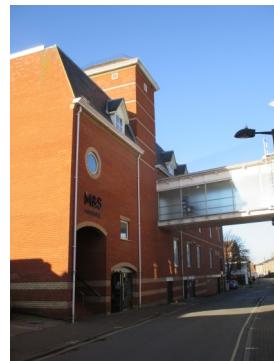
Rear 23 Buttermarket

This is the rear elevation of the Marks and Spencer store and is contemporary with the warehouse extension across the street to the east both being built at the same time in the 1990s in a kind of late 'Post Modern' style. The two elements are linked by a glazed footbridge (which could be kept clearer of clutter than it often is). This western building is again in three tall storeys of red brickwork with ground level entrances at the north end for staff/servicing/collection and another in the southern part of the elevation at first level, accessed by steps, providing a rear customer entrance to the ground floor shop floor when entered from Buttermarket. The street descends to the north which means the ground floor, with some buff brick banding, diminishes in height to the south. There are other openings with services doors and louvred panels between. These openings have steel lintols. The customer shop entrance to the south has arched brick openings, for the lift and the brick clad staircase. At second floor level is a buff brick band. On the first and second floors are rather randomly located fixed casements with brick arches and there is a faux stone cornice/gutter to a slated faux mansard roof which has, above, what appears to be a plant room. This has slated cladding to its sheer walls and can be seen in long views from the north. At the south end is a lift tower which projects above the remainder of the construction, this has buff brick banding and a hipped slated roof. Metal rainwater goods.

To the north of the building is a narrow space which is protected by a metal balustraded gate. This is another location in the street for dumpsters. At the south end set back behind a loading bay is a single storey extension, in red brick with a tiled roof and ledged and a pair of braced doors. This is attached to a loading platform where the store's rubbish is stored in the open air exposed for all to see. The issue is exacerbated by the lack of enclosure on the street to the south as this allows views of the entire blank façade of the store building which would not be visible if the street were properly built up. Again this is another space in the street which detracts from the conservation area.

While the spaces to each end of the building are eyesores the actual store building itself has, considering its size and commercial nature, been assimilated into the conservation area reasonably well. It would be improved were the south elevation not visible and if the two spaces flanking it were improved. As it is overall the building's contribution to the conservation area is neutral while the flanking spaces detract.

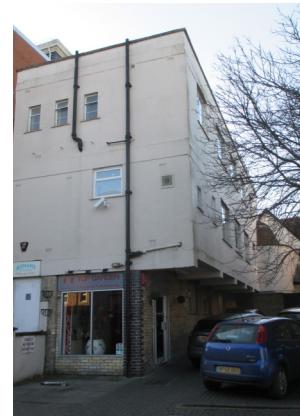
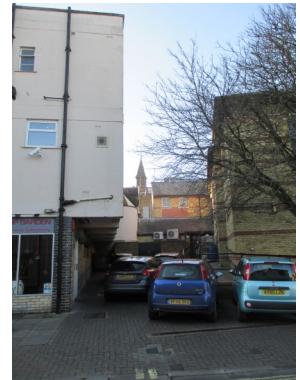
30 High Baxter Street

This is a building, presumably from the 1960s which is in three storeys, the upper two cantilevering over the ground floor on the north side. The building, which is in mixed white and blue brick at ground level appears otherwise to be stucco rendered, but with projecting concrete bands at each floor and roof level. There is an access to a shop in Buttermarket to the south, a takeaway food outlet to the north, and access to residential or office accommodation above on the north elevation.

Above the ground level facing north the elevation has four large and two smaller windows at first floor and five large ones at second floor. The east facing elevation, which is that which faces the street (the north elevation is rather hidden behind trees) is plain in the extreme with three small WC type windows at second floor and one somewhat larger at first floor. There is a flat roof hidden by a parapet

The setting of the building is not improved by the ground level car park to the north, or the dumpsters which are stored adjacent. This could only really be worse if the trees which are planted in the public realm to the north on the corner of Brentgovel Street were not there.

This is not a good building in the conservation area and along with the open space to its north it detracts from it.
