Raingate Street

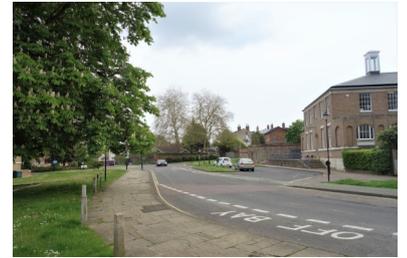
The road is finished in asphalt with concrete flagged pavements and grass verges which lend something of a sub-urban/ parkland feel to the location. Modern 'heritage style streetlights on columns. At the south end there are folksy telephone poles and overhead cables and outside of the 'Civic' area the pavings are asphalt.

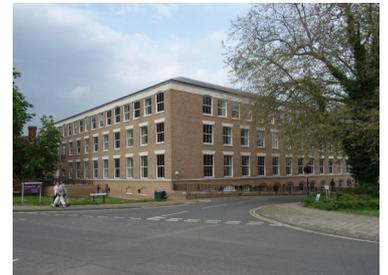
Former Shire Hall, Raingate Street

What was constructed is, in effect, an 'L' shaped office building which has similar elevations to each side and the two longest elevations are visible in Raingate Street. The building has three storeys of buff brickwork set upon a base which forms a lower ground level at the rear and a semi basement at the street frontage. This has a stone plat band at ground level and is generally blind on the west facing elevation while basement level windows emerge on the south facing elevation. Somewhat curiously there are more bays of fenestration at second floor level than on the floors below where there are thirteen to each elevation. The three over three sash windows have stone lintols and cills and the parapet above the second floor windows is also in stone - here some openings have the affection of arched openings. All the basement level openings have arched brick lintols. The four bays at the northern most corner of the west facing elevation includes the entrance, these are rather eccentric and include French casements with balconettes at first floor level, the entrance door and a recessed arch headed opening, with a similar blind opening adjacent. At second floor level the coat of arms of the West Suffolk County Council has been retained. Flanking the entrance are a pair of smaller windows with brick arched lintols.

Westmoreland slate (?) roof with metal parapet gutters in black.

The entrance is now accessed by a brick clad ramp and steps which are a more recent addition.

This is a reasonable, if rather pedestrian design, but is an important building as it was built for a Civic use and so has an historic significance which adds to any architectural interest which means it makes a positive contribution to the conservation area.

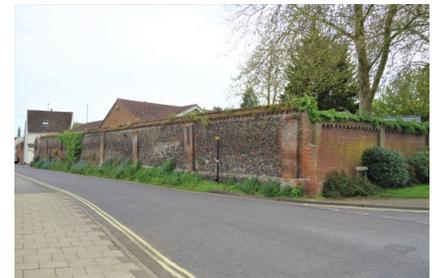
Walls to No1 Swan Lane

In Swan Lane parts of the walls are protected by statutory listing but other rebuilt elements there are not. Neither of the walls facing onto Raingate Street are listed. These walls are tall, about eight feet, and they are built with flint and brickwork with brick dressings in the forms of piers and copings.

The modern house behind these walls does not make any contribution to the conservation area but the historic walls certainly make a strong contribution, even where rebuilt, as they reflect the enclosures of the 18th C gardens to the large houses in St Mary's Square and are characterful elements in the conservation area.

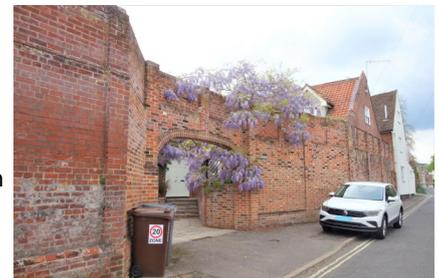
Walls to No 69 Raingate Street

While the house behind the walls is modern and makes no contribution to the conservation area, the walls to the street frontage, despite having been heavily repaired and/or rebuilt, do make a positive contribution for similar reasons to those to No 1 Swan Lane. Part of the modern dwelling appears to incorporate some of the walling and a gable with window can be seen projecting above the wall - a more recent type of red facing brick has been used in the construction of the gable and this is far less weathered than the remainder of the wall.

Here the walls are very tall and in brick mainly in Flemish bond and have been altered to allow access to the area behind. They are typical of the garden walls from the 18th C that are so characteristic of many parts of the conservation area and make a strong positive contribution to it.
