Risbygate Street

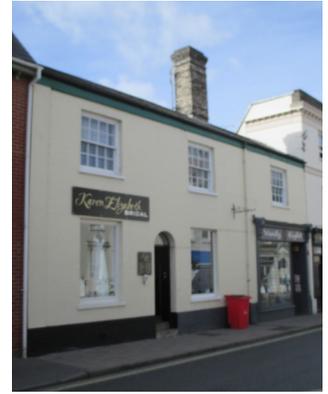
96 Risbygate Street

This appears to be another early 19th C two storey building which in this case appears to have been constructed with a shop on the ground floor and a first floor flat. It is in two storeys of painted brickwork with a slated double pitched roof with white brick stacks.

There are four window openings at first floor level with six over six sashes while at ground floor the shop front stretches almost the full width and incorporates the residential entrance doorway at the western end. The sash windows are original, as is the shop front with reeded pilasters and original flush panelled doors with that to the shop being half glazed. However, the frieze has been altered, as have, presumably, the shop windows themselves, which now have very large panes. The flanking elevations are painted brickwork blind to the east and with a single first floor sash window to the west. Plastic rainwater goods.

This is one of a collection of late Georgian buildings in the street and one which has early shop joinery. It makes a strong positive contribution to the conservation area.

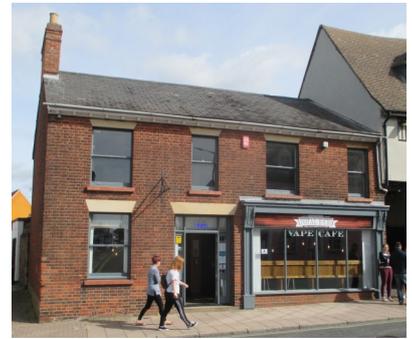
97 Risbygate Street

This is a late 19th C purpose built shop with a flat above. It has two storeys of red brick-work with a double pitched slated roof with a bracketed eave and brick stacks.

There are four bays of fenestration on the first floor with sash windows. On the ground floor is a single sash window to the west, the entrance door and the shop front which has mullioned glazing. There is no separate door to the upper storey. All the joinery is original except the entrance door and screen. All the openings, except the shop front, have stone lintols.

The west facing elevation is also in matching brick and is blind.

Plastic rainwater goods.

This is a smart later 19th C version of other similar premises in the street and it is typical of this part of the conservation area, to which it makes a positive contribution.

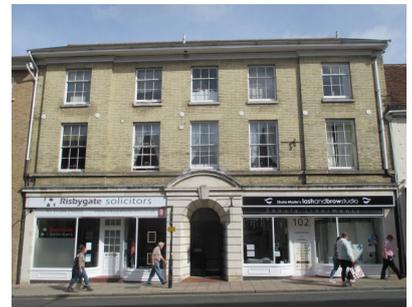
101-102 Risbygate Street

This is a large early/mid 19th C purpose-built shop premises with two storeys of residential accommodation above. Above the ground floor the construction is in white bricks with five bays of fenestration. The two extreme flanking bays break forward helping to break up the elevation. The windows are all multipane sashes and all have flat gauged arched lintols. There is a stone plat band at first floor level above the ground floor shop fronts. At the centre of the ground floor is the entrance portico, with banded ashlar and arched opening below an arched pediment with an expressed key stone. Flanking this are the shop fronts with recessed entrances. All the joinery appears original but the door to the east shop is boarded over. The doors are panelled, with the shops being half glazed with mutipanes, and the shop windows are mullioned.

The double pitched roof is slated.

Plastic rainwater goods.

To the west is a modern pastiche extension which demonstrates quite how mediocre contextual architecture can be when in the hands of those who do not understand the architecture they are copying. This extension detracts from the conservation area.

The original building, by contrast, is a strong early/mid-19th C building of very high quality both in design and construction. It is another early purpose built mixed use building and makes a very strong positive contribution to the conservation area.

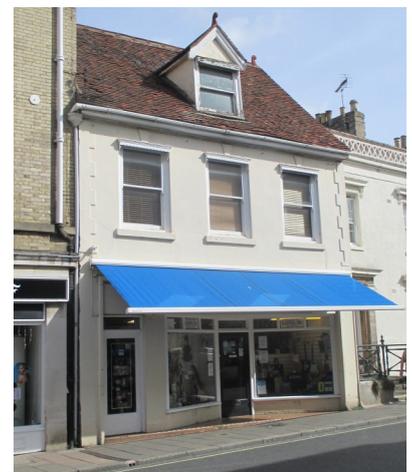
103 Risbygate Street

This is a mid/late 19th C building in two storeys of stucco rendered finish with three windows at first floor above a ground floor shop front and upper storey entrance with a double pitched tiled roof with a gabled dormer. The elevation has flanking relief quoins to the extremes and the windows all have relief expressed key stones, while the stucco is finished as faux ashlar. The windows are sashes and original joinery, and each has a decorative blind box from the late 19th/early 20th C although none seem to now have blinds.

At ground floor the recessed canted shop front is original but the glazed entrance doors are later 20th C.

Plastic rainwater goods.

This is a good building with some pretensions which is another purpose-built mixed use building typical of this part of the conservation area to which it makes a positive contribution.

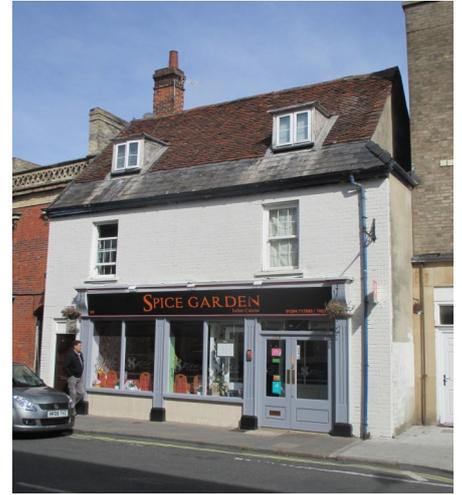
109 Risbygate Street

This is something of a confection of a building which may be a much older than it appears. Without an internal inspection it is not possible to tell what its origins are but, in terms of its relationship with the conservation area, it has a heavily restored street elevation with two storeys of white bricks (now unfortunately painted) from the first half of the 19th C with a pair of sash windows at first floor level and a door to this accommodation and a shop front at ground floor level. The openings, other than the shop front, have stone lintols. The roof is double pitched with mainly clay tiles but with a slated apron and a red brick stack. This slated apron returns in a tiled hip to the east where there seems to have been some later alterations. There are two lead clad dormers with plastic casement windows which detract. The other joinery is all faux Victorian of limited quality.

The building breaks forward in front of the others in the terrace and the east flank is stucco rendered, while the west is brickwork.

Plastic rainwater goods.

This is an intriguing building which makes a modest contribution to the conservation area, despite its plastic windows. It may reward further research.
